# Renovations in Stratas

## What You Need to Know About Asbestos

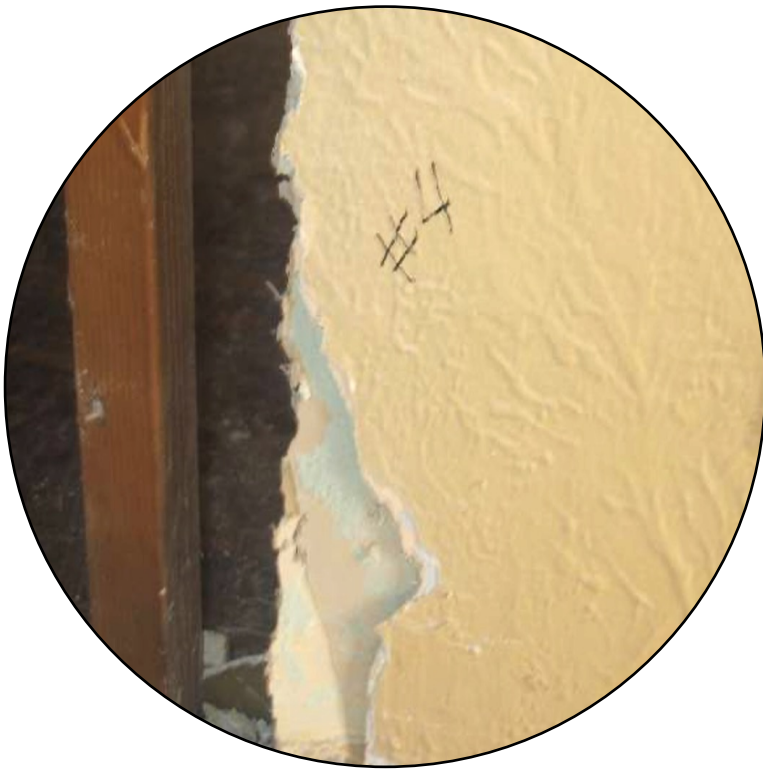
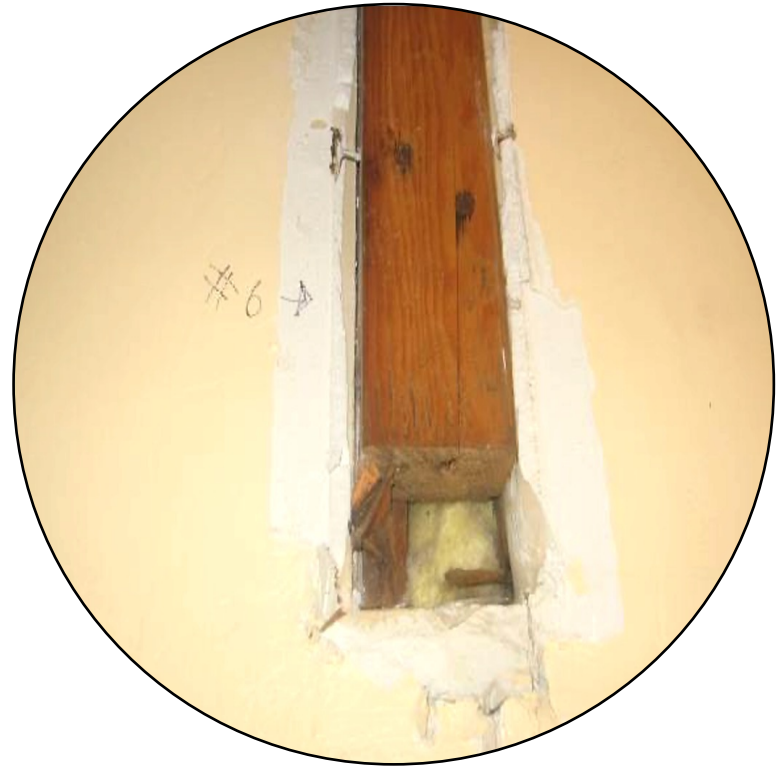
Wall texture coat

Drywall joint compound

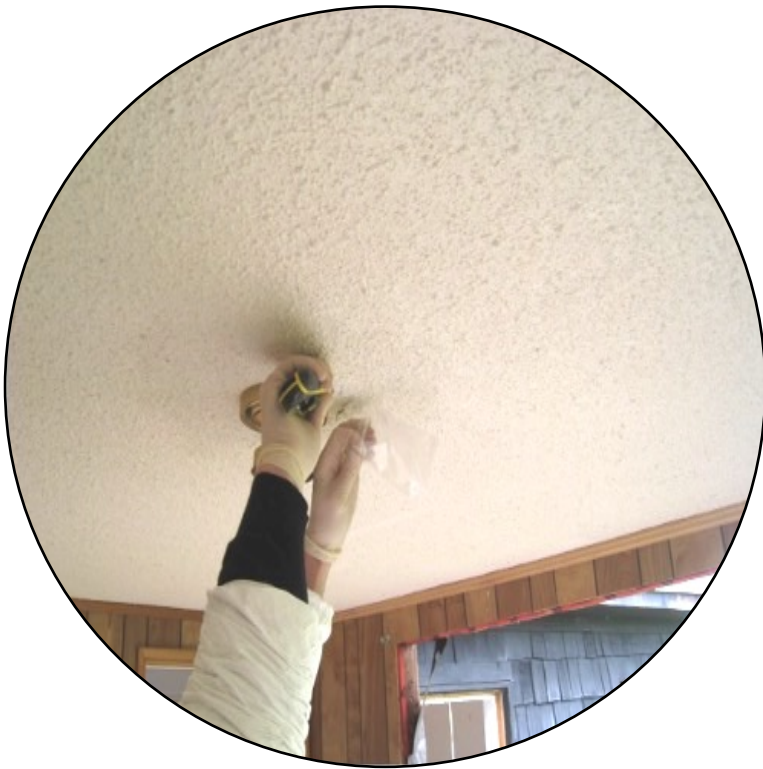
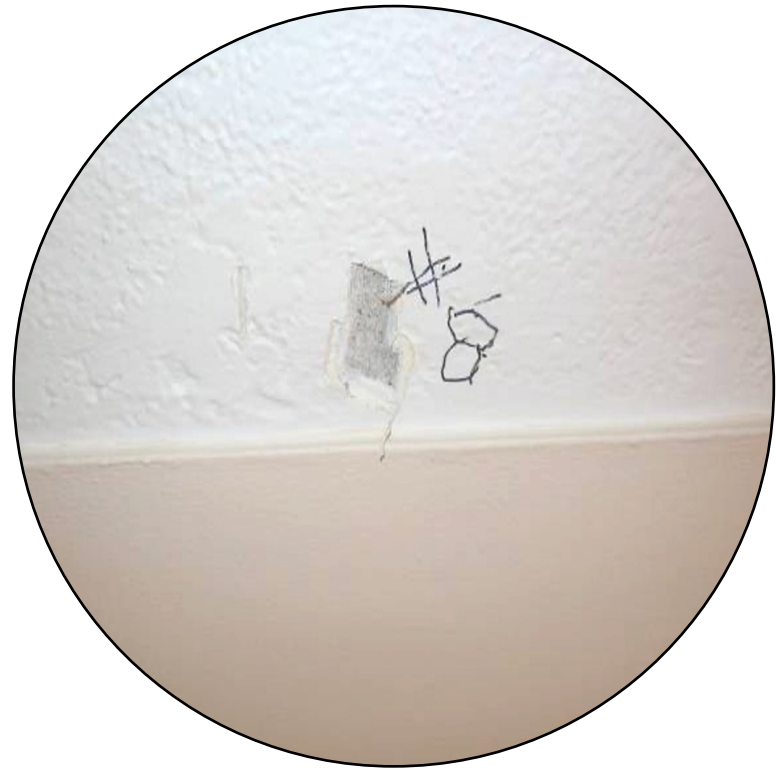
## Ceiling texture coat (popcorn ceiling)

## Wall or ceiling plaster

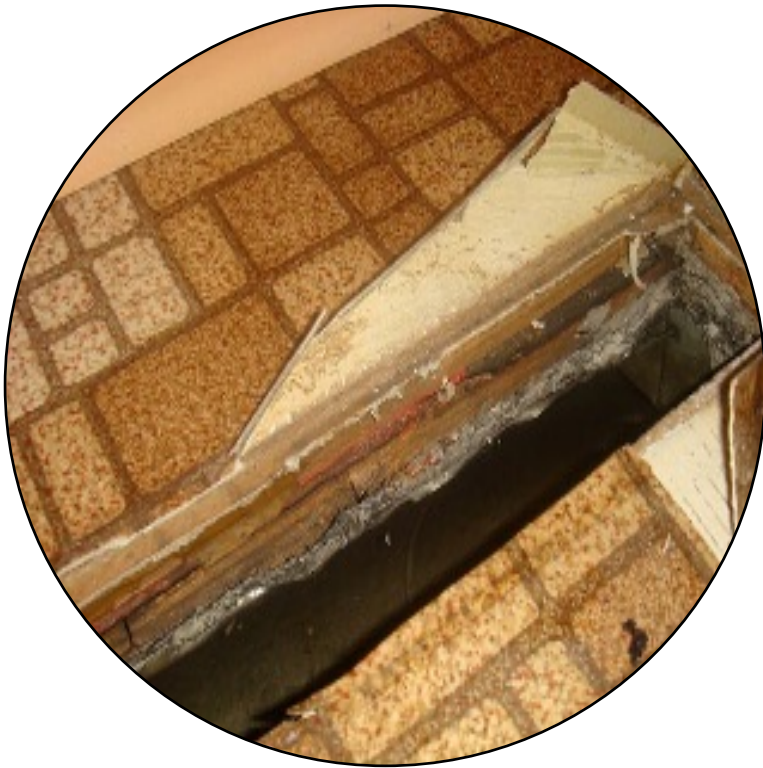
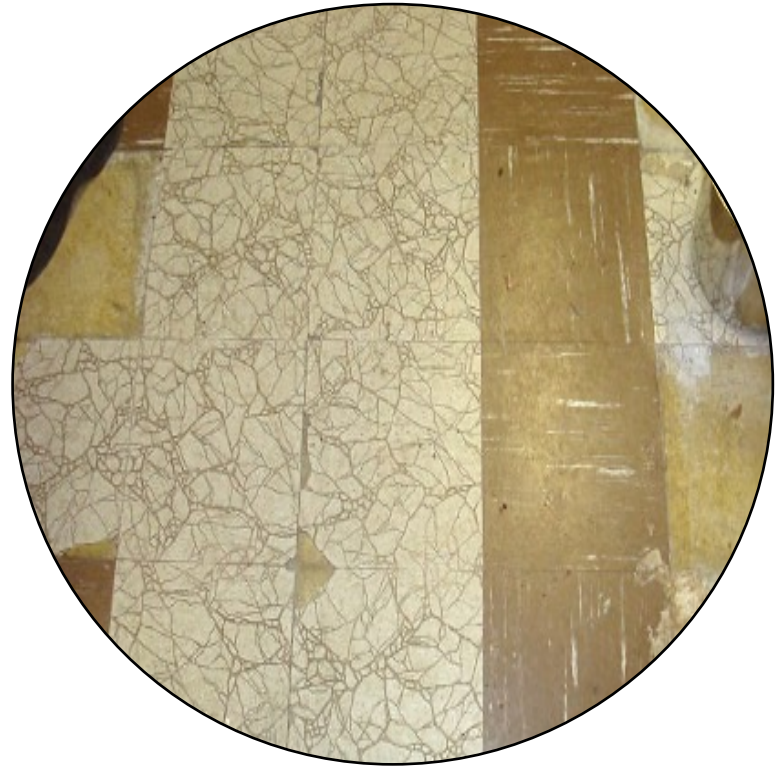
Sheet vinyl flooring

Vinyl floor tiles

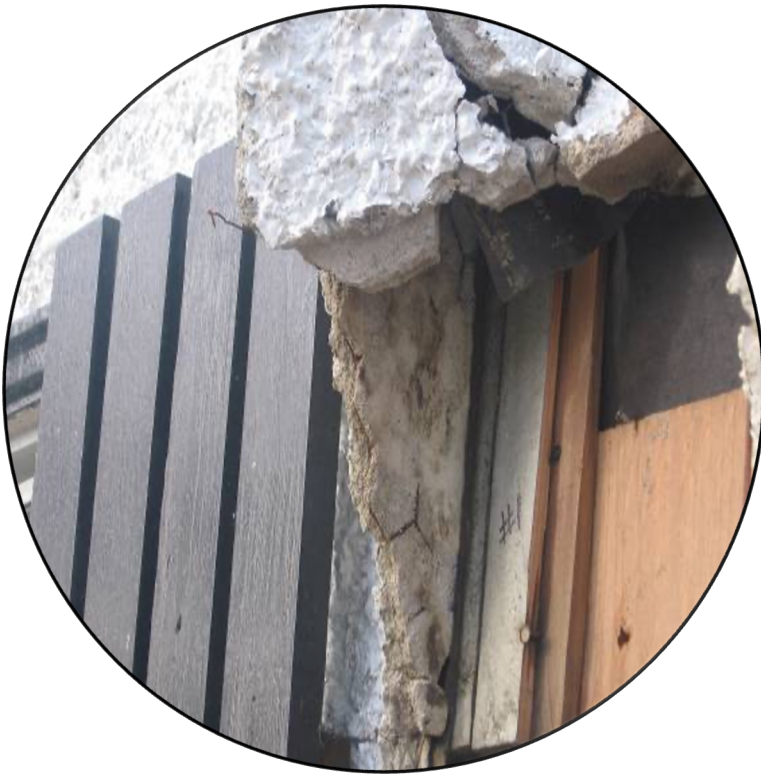
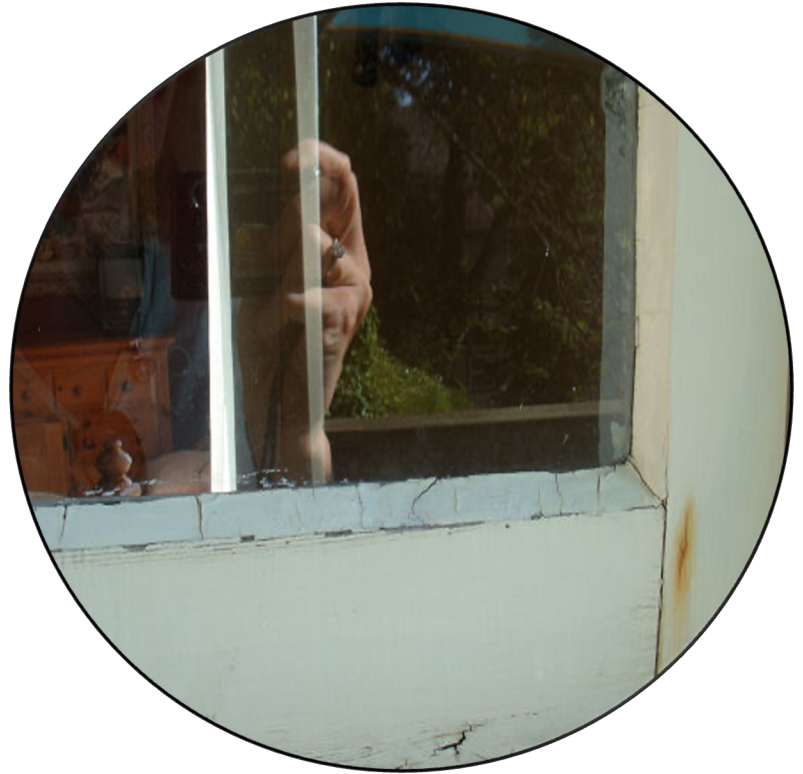
## Stucco

## Caulking

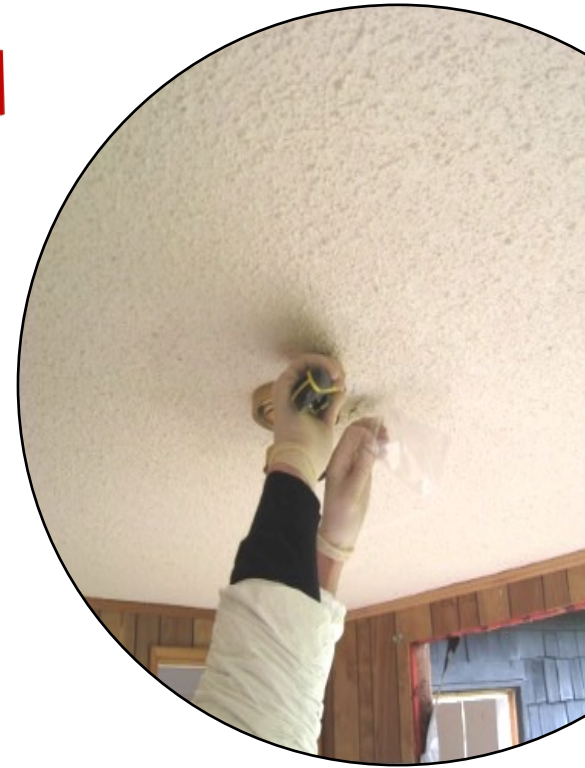
# Popcorn ceiling texture removal

## Abatement Method: Removal

### Risk level: High

High level of controls needed to prevent worker exposures to asbestos fibres (released into the air)

- Full enclosure & negative air (HEPA)
- Workers: disposable coveralls, rubber boots, PAPR (respirators)
- 3-stage decontamination facility (with shower)

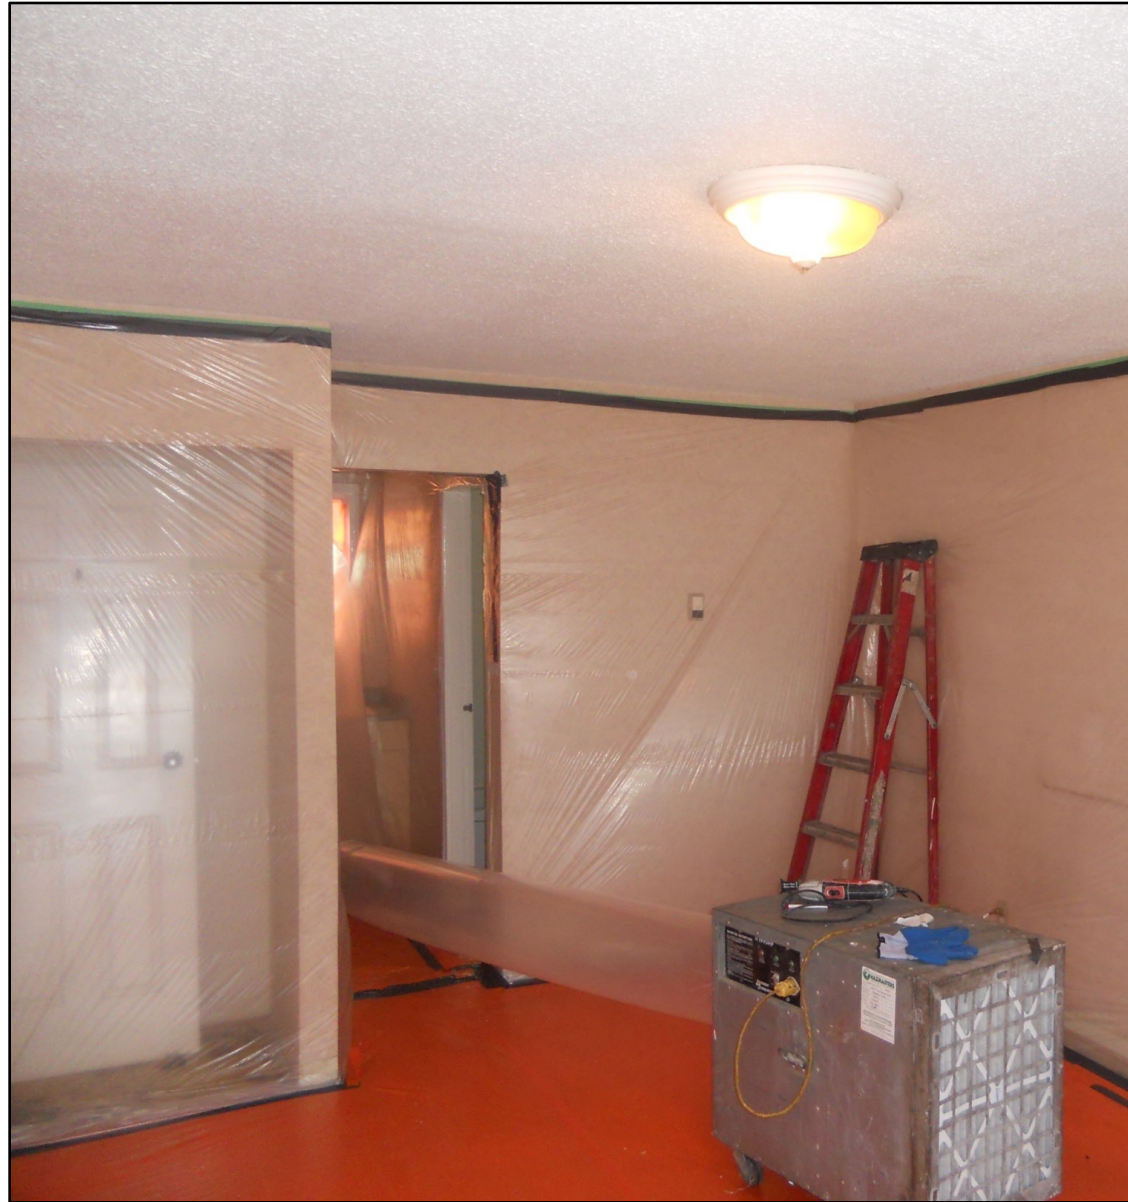
# Popcorn ceiling texture removal

- Full enclosure & negative air

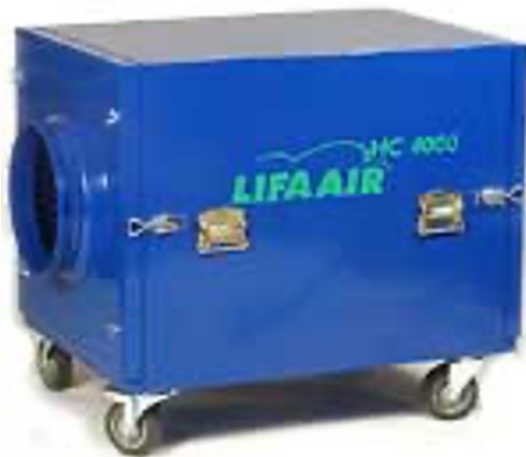
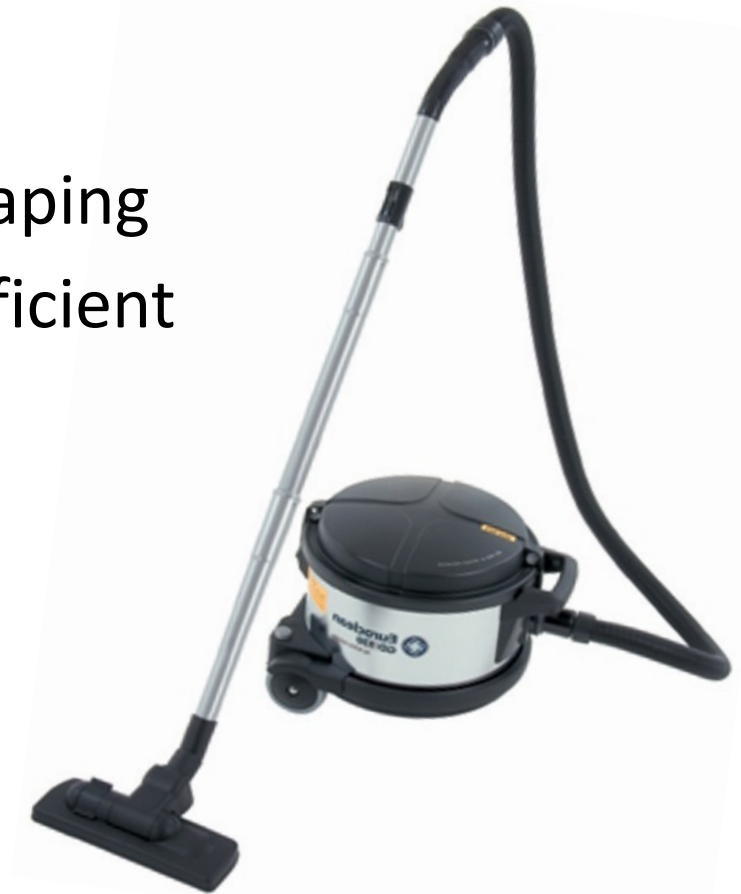
# Negative air

Machines and HEPA vacuums

- Keeps contaminants from escaping
- HEPA filter exhaust – 99.97 efficient

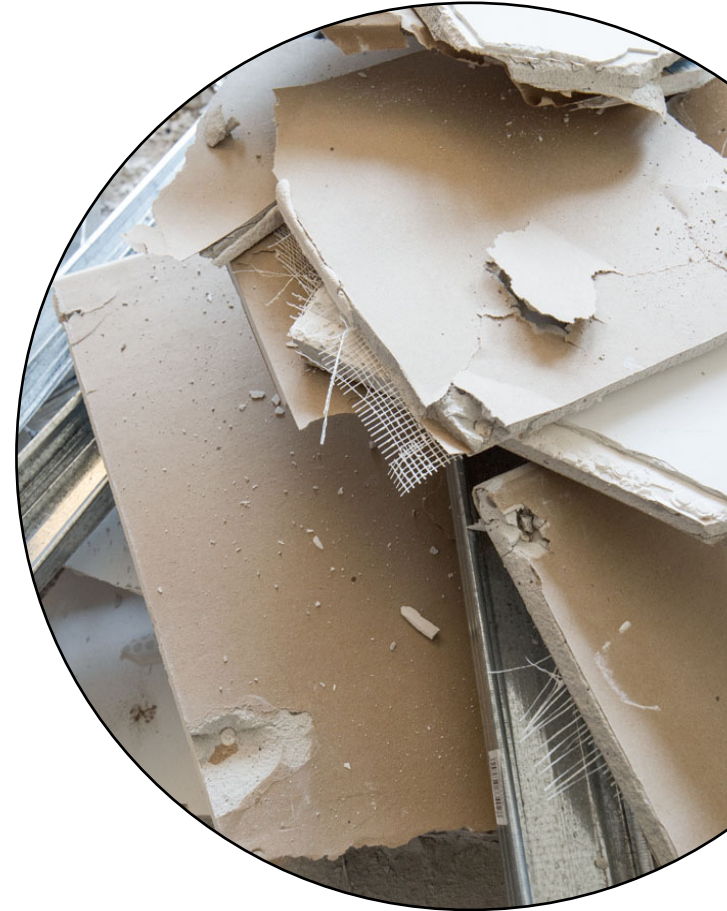
## Kitchen wall removal

**Abatement Method: Removal**

**Risk level: “Modified” Moderate**

- High dust activity
- PPE: coveralls, rubber boots, PAPR (respirators)
- Full enclosure & negative air
- 2-stage decontamination (shower not required)

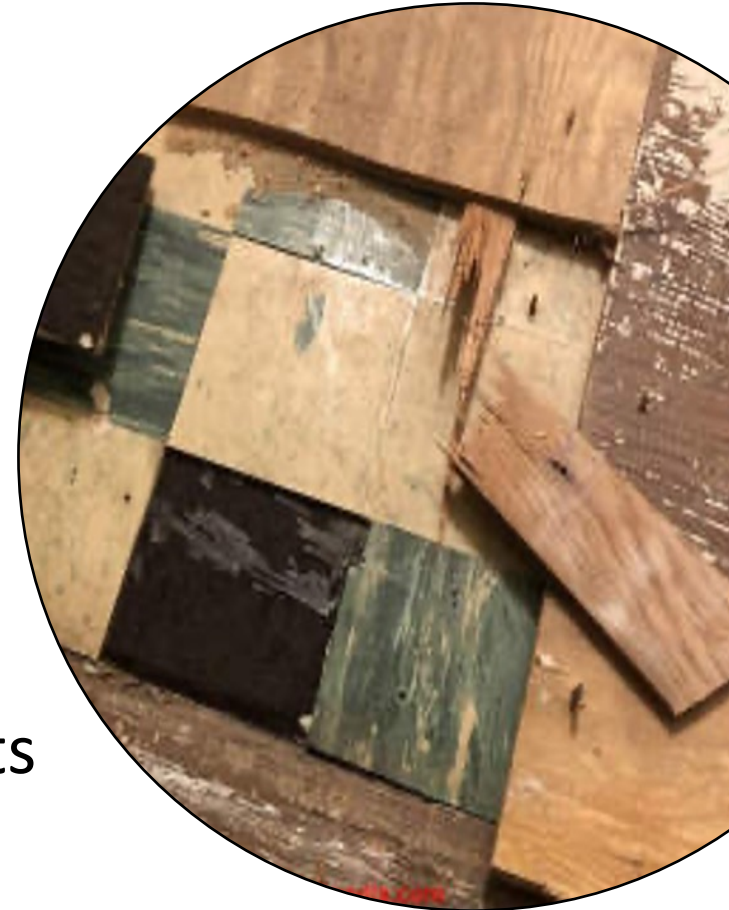
## Kitchen sheet flooring

**Abatement Method: Enclosure**

**Risk level: Moderate**

- Install ¼" plywood over vinyl flooring
- Creates a physical barrier between asbestos containing materials and building occupants
- Avoids aggressive disturbance
- PPE: coveralls, boot covers, half-face respirator
