# Depreciation Reports & The Strata Property Act of British Columbia

→ Matt Mulleray, P.Eng.

April 29, 2012

Nanaimo, BC

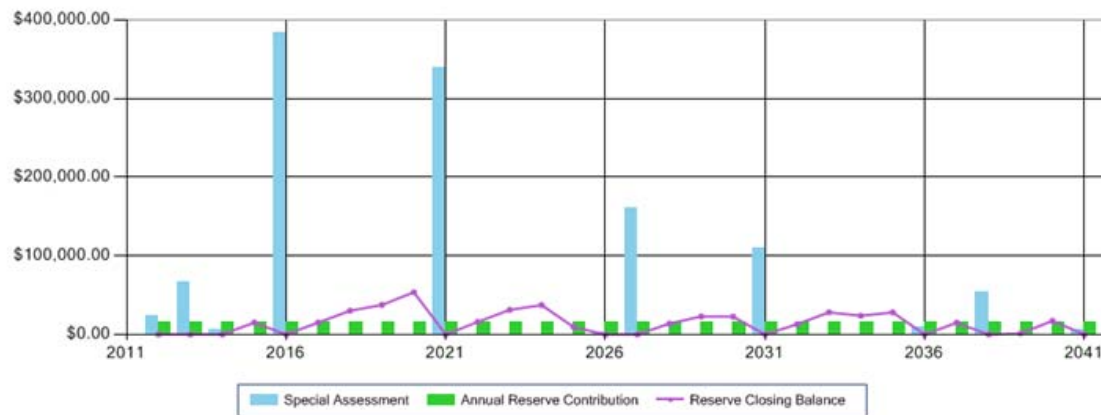
Fig. 5.2.2 Status Quo Funding Model \$16,000: Graphical Analysis

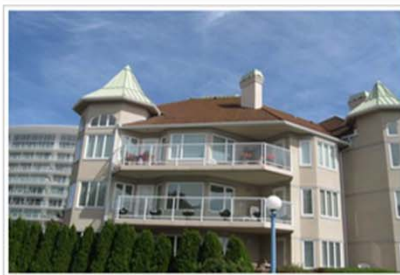
## Metal-clad Turrets

Location:	Turrets at east and west elevation of roof.		
Description:	Steep standing seam metal roof over a membrane underlayment.		
Chronological Age:	24	Service Life:	40
Effective Age:	24	Remaining Service Life:	16
		Outstanding Conditions:	0

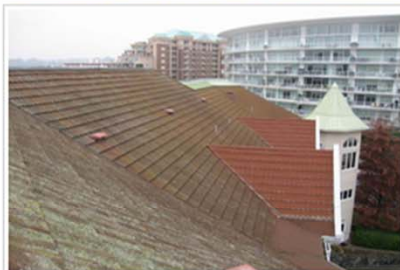
## Profiled Metal Shingle Roof

Location:	Main sloped roof area.		
Description:	Decra Bond metal roof shingles over a membrane underlayment.		
Chronological Age:	24	Service Life:	40
Effective Age:	40	Remaining Service Life:	0
		Outstanding Conditions:	3

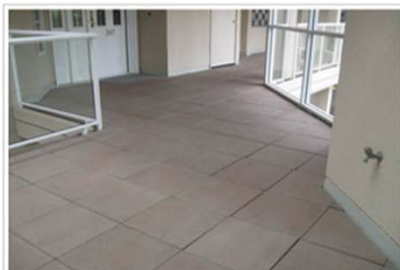
## Walkways w/ Concrete Pavers

Location:	2nd and 3rd floor walkways.		
Description:	2-Ply SBS modified asphalt thermo-fusible membrane overlaid with concrete pavers.		
Chronological Age:	11	Service Life:	35
Effective Age:	11	Remaining Service Life:	24
		Outstanding Conditions:	0

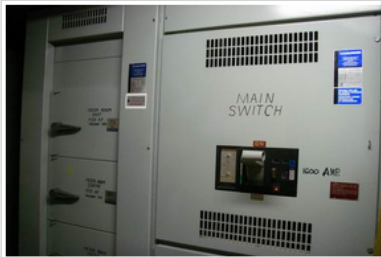
## Elec 02

### Electrical Distribution

Location:	Main electrical room on parkade level.		
Description:	Commander switchgear, distribution boards, panelboards and metering equipment.		
Chronological Age:	24	Service Life:	50
Effective Age:	24	Remaining Service Life:	26
		Outstanding Conditions:	0

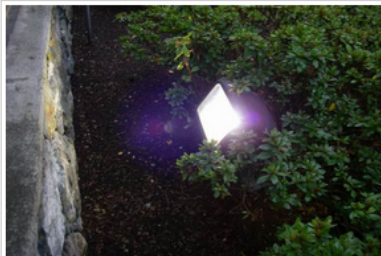
## Elec 03

### Exterior Light Fixtures

Location:	Mounted to walls and soffits; buried amongst the soft landscaping.		
Description:	A variety of fixture types, including recessed pot lamps, wall mounted fixtures, and landscape lighting.		
Chronological Age:	14	Service Life:	20
Effective Age:	14	Remaining Service Life:	6
		Outstanding Conditions:	0

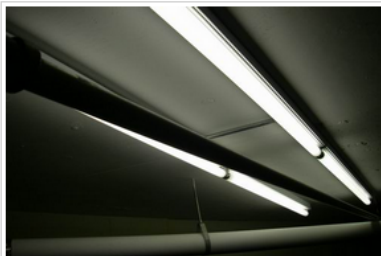
## Elec 04

### Interior Light Fixtures

Location:	Parkade, hallways, service rooms.		
Description:	A variety of fixture types, including incandescent and fluorescent, wall mounted, recessed ceiling pot lights, pendant fixtures, compact fluorescents, and strip fluorescent fixtures.		
Chronological Age:	12	Service Life:	25
Effective Age:	17	Remaining Service Life:	8
		Outstanding Conditions:	0

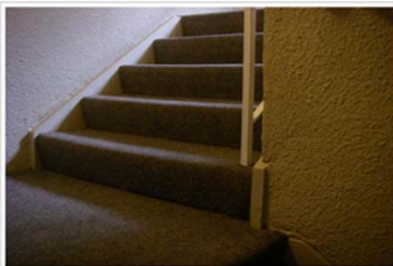
### Finish 01

#### Carpet Flooring

**Chronological Age:** 11

**Effective Age:** 9

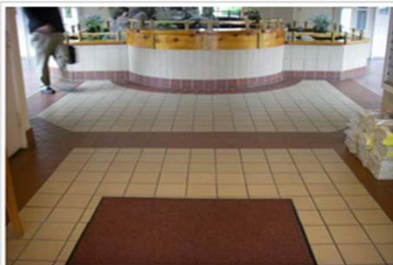
### Finish 02

#### Tiled Flooring

**Effective Age:** 20

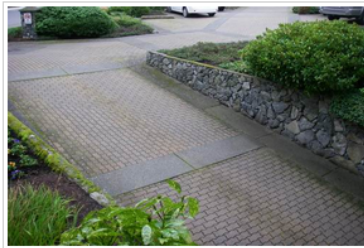
Site 02

## Interlocking Unit Paving

Location:	Vehicular access roadway and pedestrian access at north side of building.		
Description:	Concrete unit pavers, combination of joint filler and jointing sand, bedding sand, compacted gravel base, compacted sub-base.		
Chronological Age:	24	Service Life:	40
Effective Age:	24	Remaining Service Life:	16
		Outstanding Conditions:	0

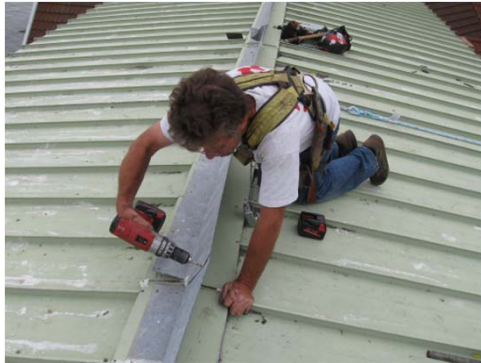
They require periodic maintenance...

- Cleaning
- Lubricating
- Adjusting
- Inspecting

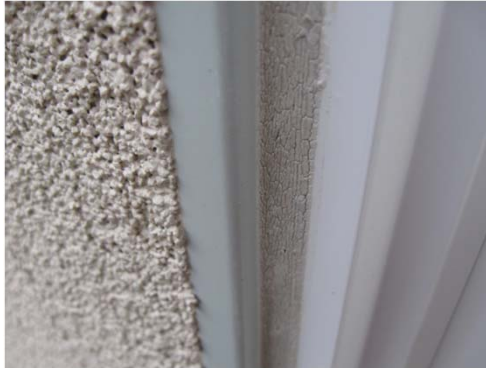
They deteriorate over time...

- Cracking
- Staining
- Splintering
- Corroding

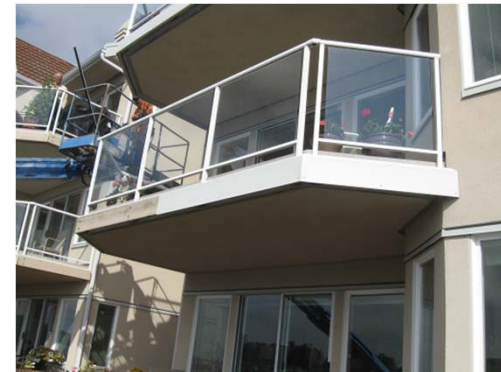
They eventually need to be replaced...

- Balcony fascia improvements
- Re-roofing
- Carpet replacement
- Elevator modernization

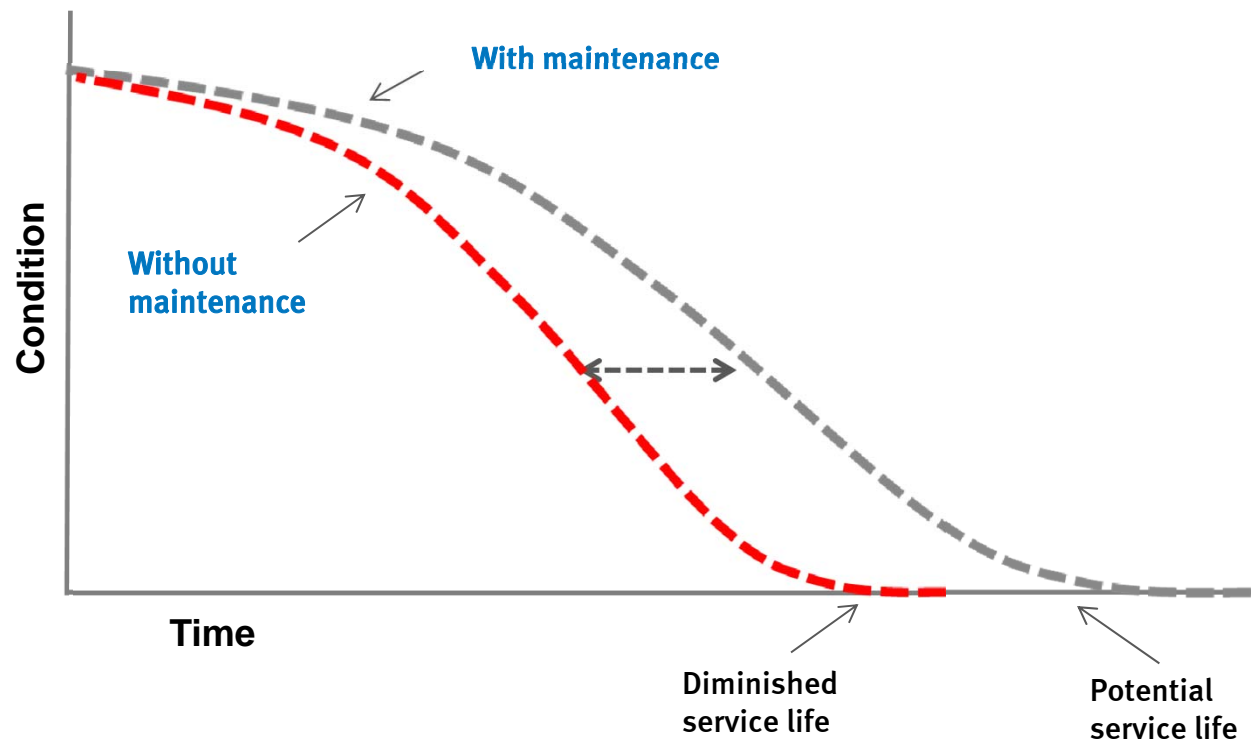
# Impact of Maintenance on the Life of Assets

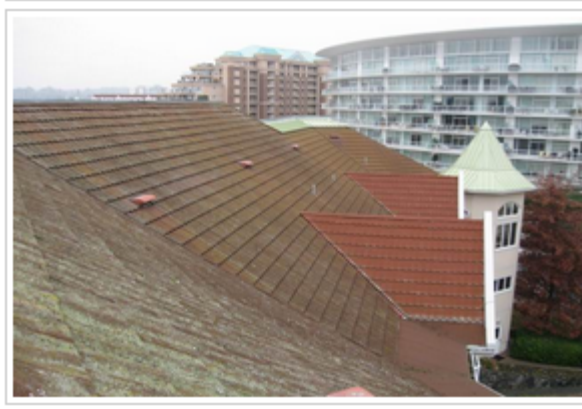
## Encl 04

### Profiled Metal Shingle Roof

Location: Main sloped roof area.

Description: Decra Bond metal roof shingles over a membrane underlayment.

Chronological Age:	24	Service Life:	40
Effective Age:	39	Remaining Service Life:	1
		Outstanding Conditions:	1

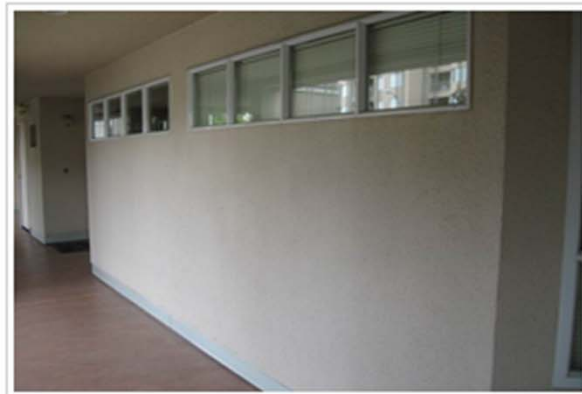
### Stucco Cladding - Face Seal

Location: Non-rehabilitated walkway suite walls and chimneys.

Description: Face-sealed stucco applied to protect exterior wall assemblies.

Chronological Age:	24	Service Life:	45
Effective Age:	13	Remaining Service Life:	32
		Outstanding Conditions:	0

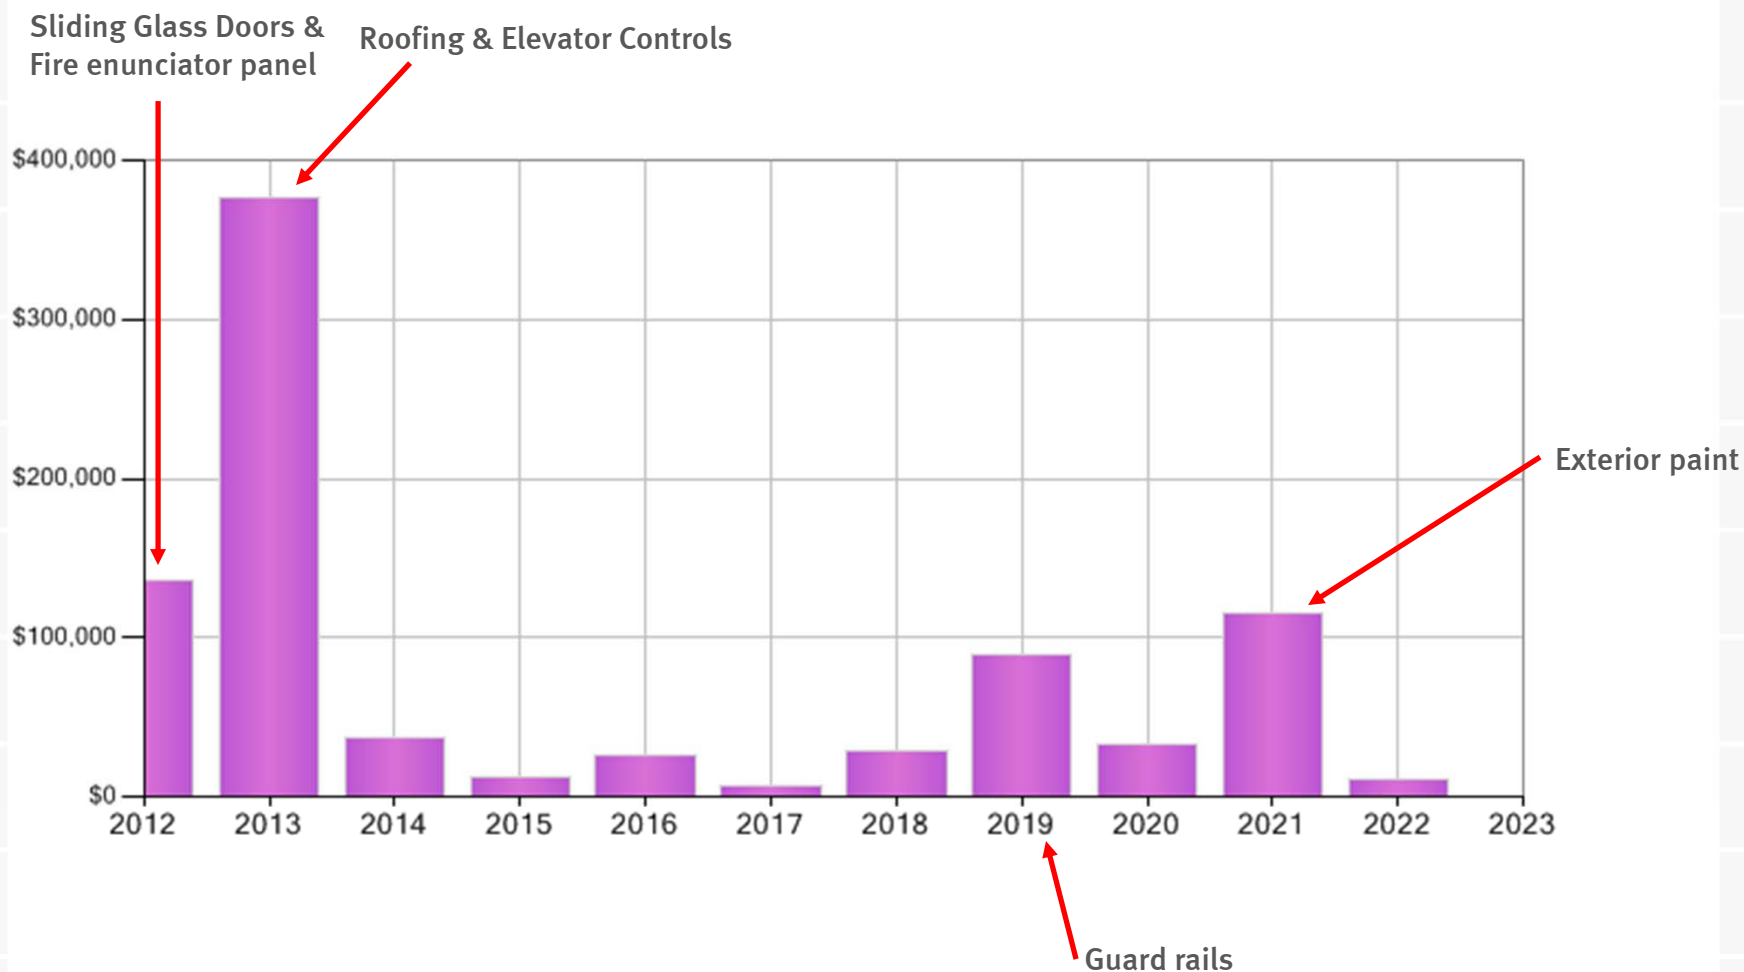
# 10-Year Forecast – Major Maintenance & Renewals

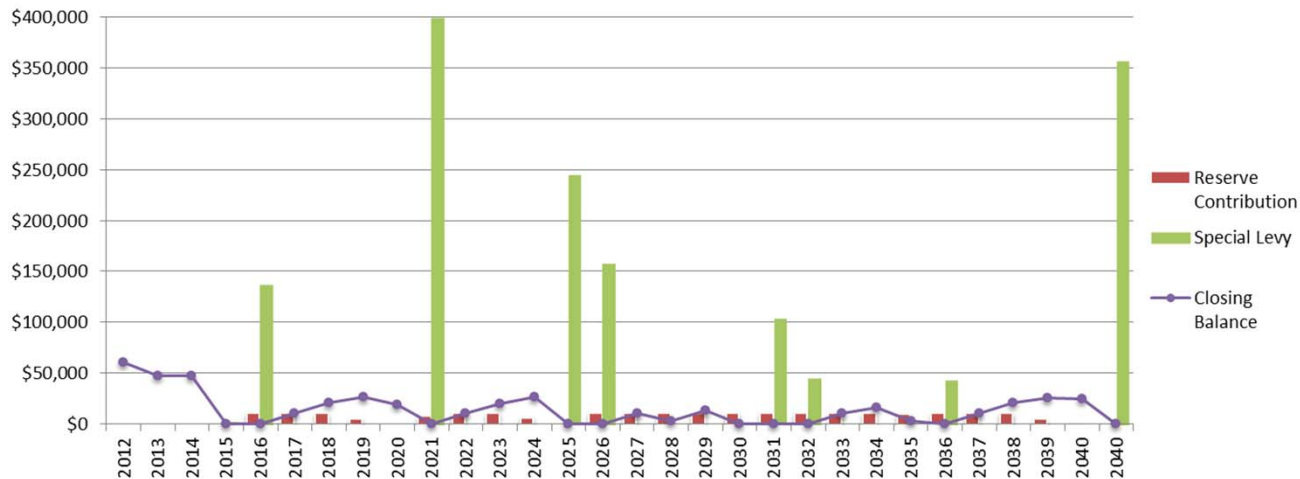
**STATUTORY FUNDING**  
(min. requirements)  
Max \$23/suite/month

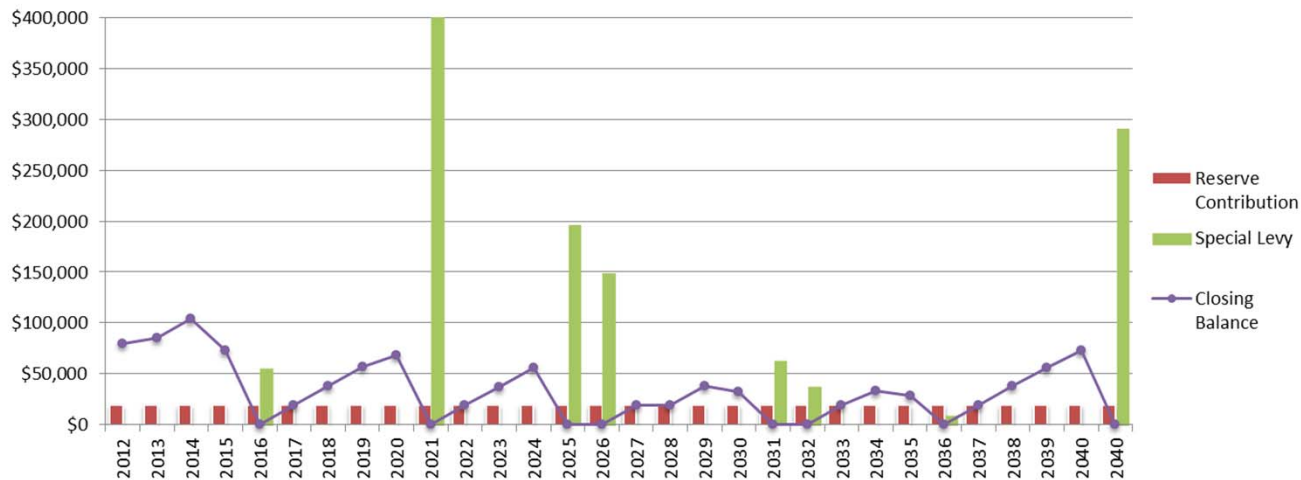
**ALTERNATE FUNDING #1**  
(User defined)  
\$40/suite/month

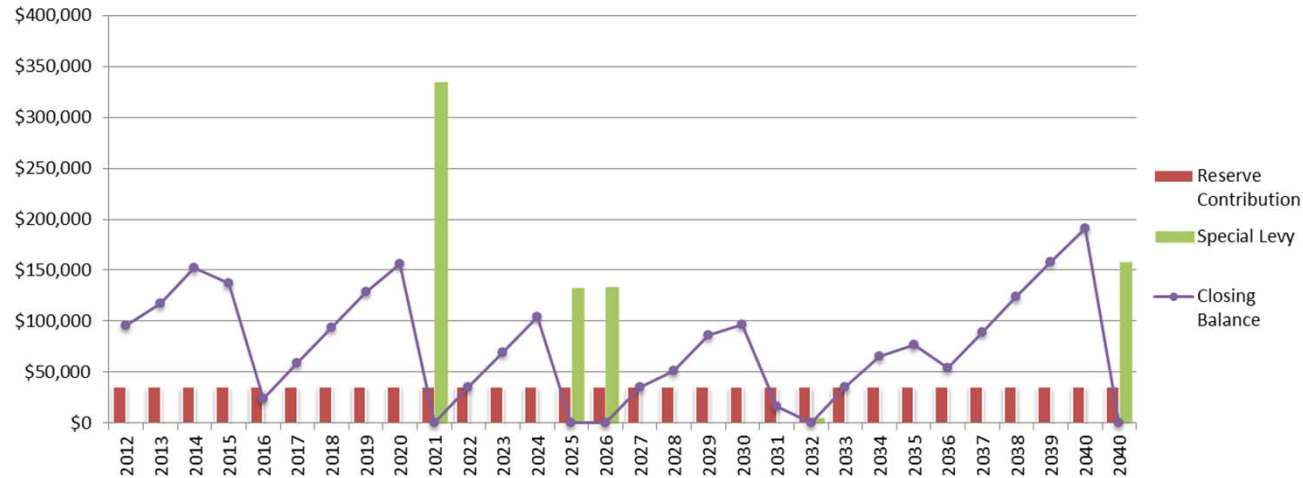
### ALTERNATE FUNDING #2

(User defined)

**\$75/suite/month**

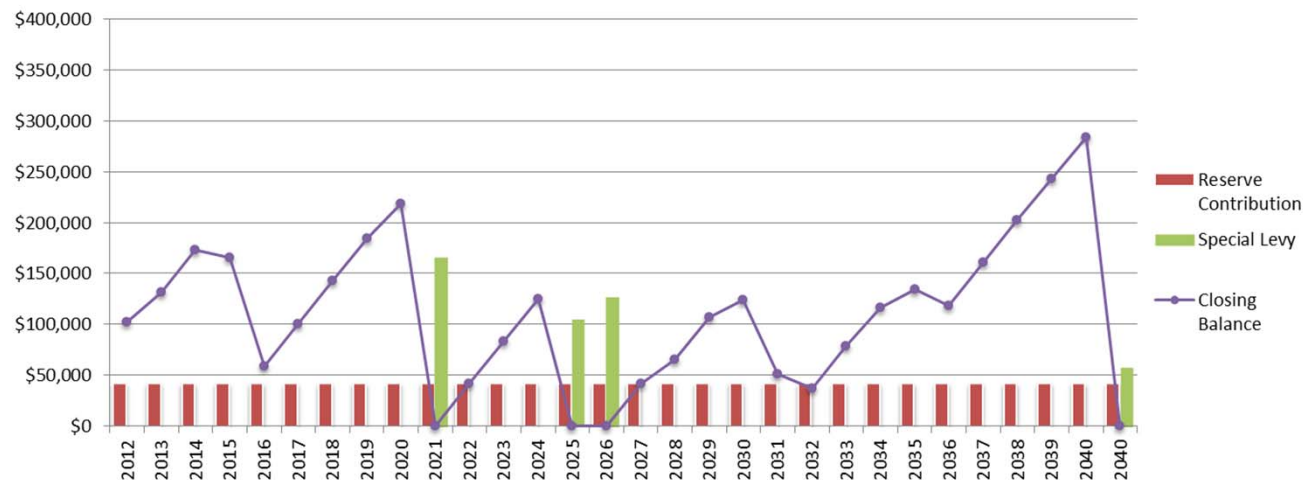
### ALTERNATE FUNDING #3

(User defined)

**\$96/suite/month**

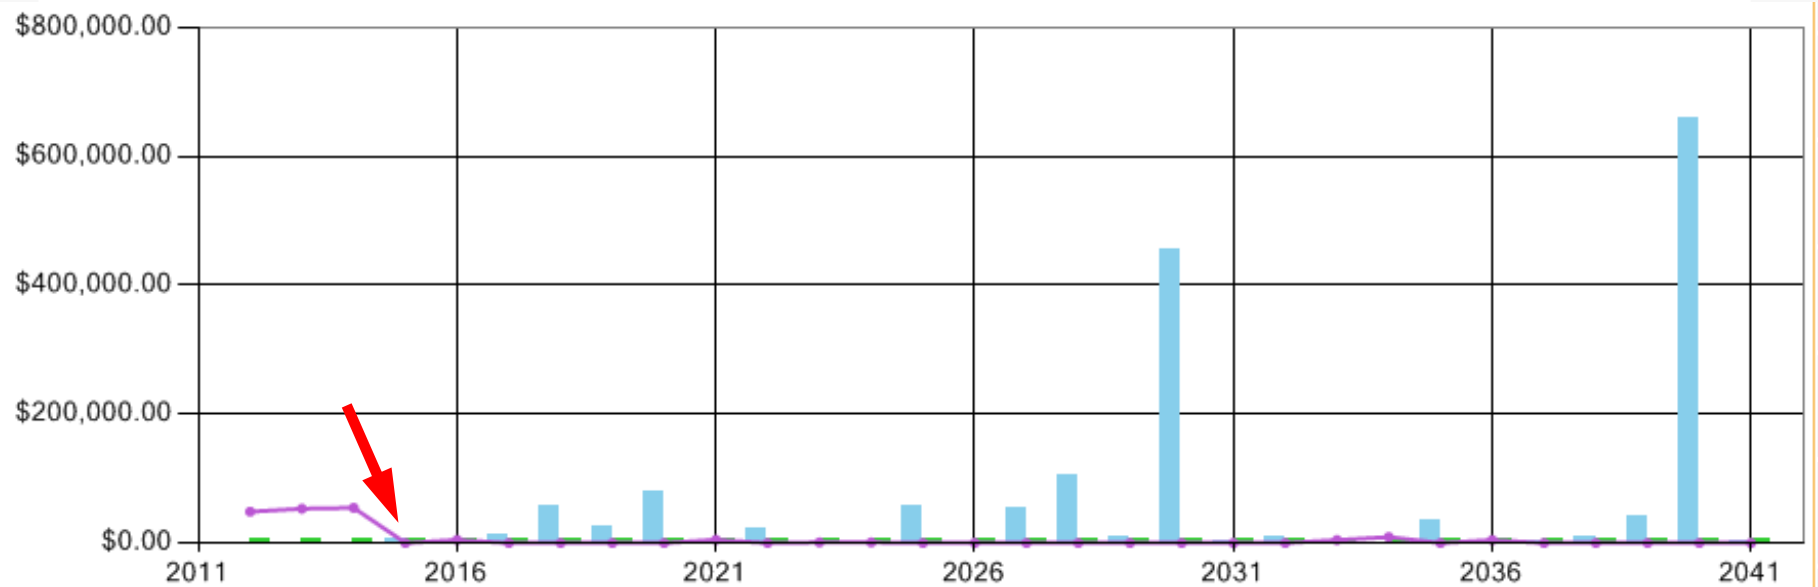
## ➤ Funding Models – Discussion on Minimum Funding

- Operating budget = \$60,000
- 25% of operating budget = \$15,000
- 10% of operating budget = \$6,000
- Current CRF contribution = ???

- Legislation mandates a minimum level of funding for the CRF.
  - Based on value of operating budget
- If CRF balance is less than 25% of operating budget the strata must contribute the lesser of:
  - 10% of operating budget value
- OR
- Sufficient funds to raise CRF balance to 25% of operating budget
